COMMUNICATIONS POLE INSPECTION & MAINTENANCE PROTECT YOUR ASSETS & PROLONG THEIR LIFESPAN

Brian Reese, P.E.

Vice President, ReliaPOLE Inspection Services Co.

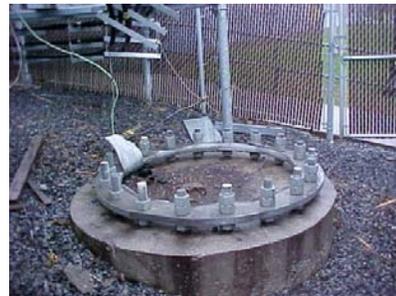
The pole failures seen in recent years possess similar characteristics:

- Cracks in the pole structure shaft wall above the base plate weld that propagate along the weld over time
- Socket base plate connection (base plate sleeves over pole wall)
- Thin base plates (under-designed) allowing for excessive movement resulting in fatigue at the base plate/pole wall welded connection

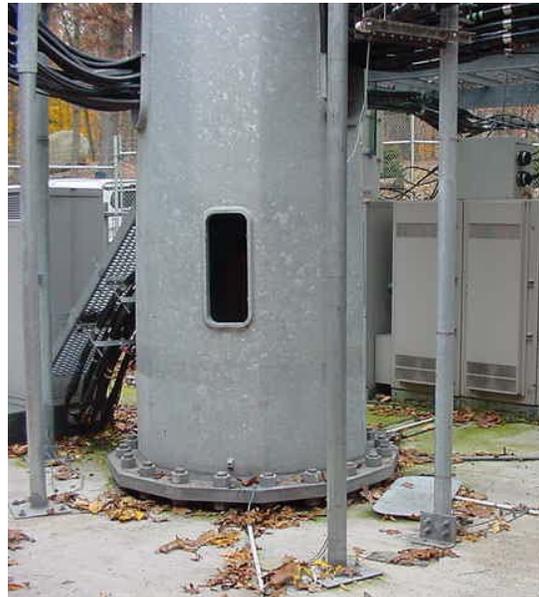
Various communications pole base details:

- Complete joint penetration groove weld – the base plate is butted against the pole shaft and consists of 100% complete weld penetration. In other words, the connection zone is all weld material.
- Socket base plate connection (base plate sleeves over pole wall) with double fillet welds.

A steel pole base plate connects the structure via the anchor bolts to the foundation. More specifically, the base plate attaches the pole shaft structure to the anchors. The connection is facilitated by welding of the members during fabrication at the original manufacturer’s facility. As the only connection and one that is non-redundant, the structural adequacy and integrity of this connection is crucial to the performance of the structure. A failure, if one was to occur at this joint, will in almost all cases be catastrophic resulting in the collapse of the pole structure. The connection detail of the pole shaft structure to the base plate can vary depending on the type of pole (multi-sided vs pipe) or the original manufacturer.

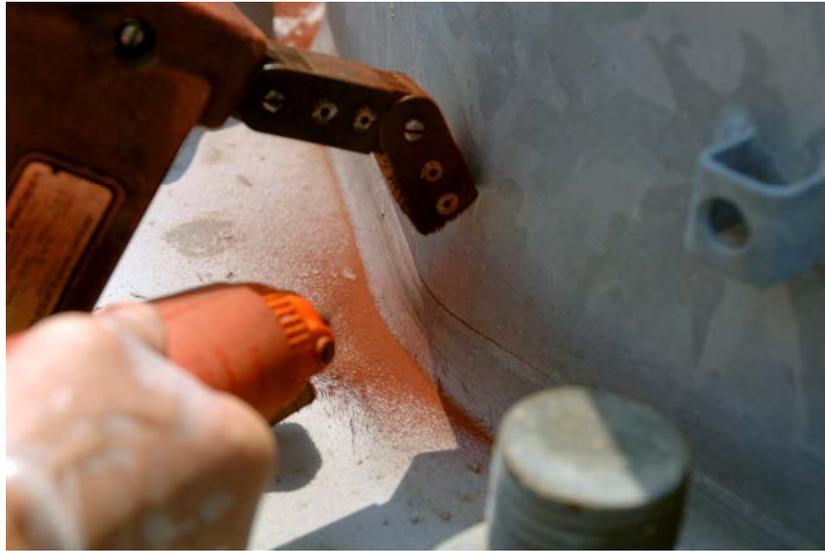
identify the presence of a crack. The crack in the picture below can be seen holding red powder.

Magnetic Particle Test (MT) Powder at Revealing Toe Crack

3. NDT Magnetic Particle Testing – Conducted by an inspector with American Society for Non-Destructive Testing (ASNT – www.asnt.org) Level II Certification. This non-destructive test is utilized to assess surface cracks in joints that are not 100% complete penetration joints; i.e. socket base plate connections. Defects hold the magnetic particle material during the test and

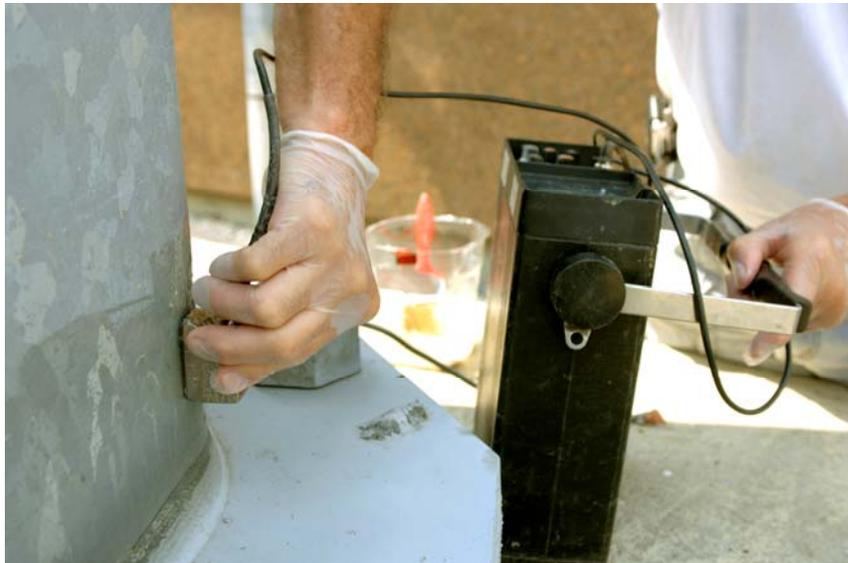
Ultrasonic Test (UT) of Pole Base Plate Weld

4. NDT Ultrasonic Testing – Also conducted by an inspector with ASNT Level II Certification. Utilized for testing of joints that are 100% complete penetration joints. The test utilizes ultrasonic waves that are interrupted by any material inconsistency (crack) in the joint.

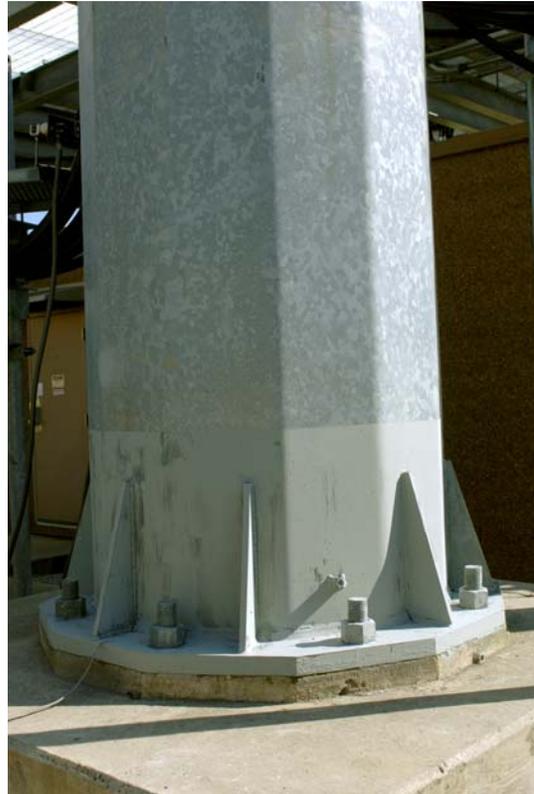
7. Assessment of Defects – Assess extent of cracks, length, and position
8. Defect Repair - The last stage is to repair the weld and/or reinforce the pole base connection. The scope of the strengthening stage will depend on the results of the diagnosis and analysis stage. Significant cracks may require drilled terminations. A reinforcement stiffener installation is shown at the right.
